AWARD-WINNING RIVER RESTORATION ON THE BLUE RIVER DOWNSTREAM OF DILLON DAM IN SILVERTHORNE, CO

Introduction

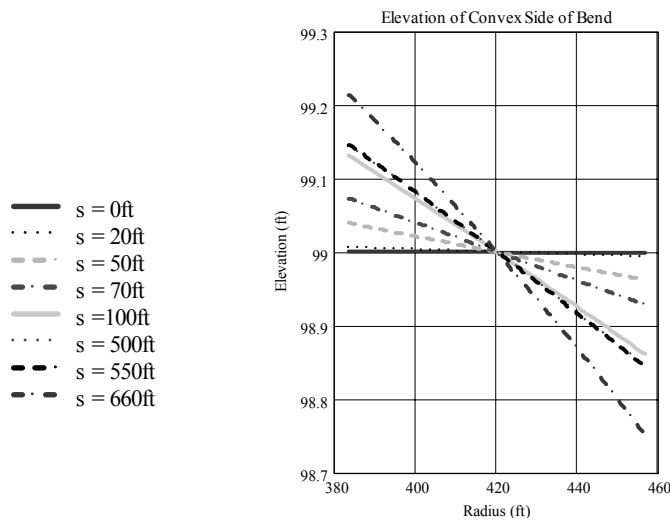
Figure 4. Cross Sectional View of Transverse Bed Slope through a Meander Bend at various locations along the perimeter (distances)

Criteria	Reference	Formula	Result
Bed and Bank	Annandale 1995	$K = M_s * K_b * K_d * J_s$	Loosely packed = 250 mm Tightly packed = 200 mm
Stability (minimum d_{50})	Rooseboom 1982	$V_{shearcri}(\rho_s, \rho, d_{50}, C_d) := 0.12 \cdot \sqrt{\frac{4 \cdot (\rho_s - \rho) \cdot g \cdot d_{50}}{3 \cdot \rho \cdot C_d}}$	280 mm
	Shields 1936	$\theta(\tau_0, \rho_s, \rho, d_{50}) := \frac{\tau_0}{g \cdot \rho \cdot \left(\frac{\rho_s}{\rho} - 1\right) \cdot d_{50}}$	260 mm
Bend Morphology	Odgaard 1986	$S_{Tc0} := \left(3 \cdot \frac{\alpha}{2}\right) \cdot \frac{(\sqrt{\theta}) \cdot (m_{dash} + 1) \cdot F_{DC} \cdot d_c \cdot b}{\kappa \cdot (m_{dash} + 2) \cdot b \cdot r_c}$	See Figures 3 and 4

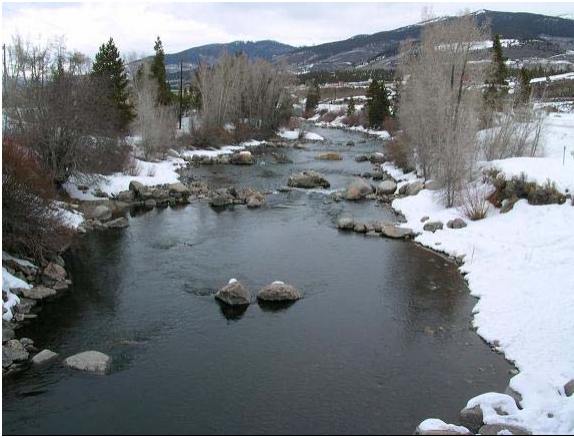
Photo 1. Pre-construction, taken from bridge below dam.

Project design focused on creating these features. Deep over-wintering pool habitat was one of the primary objectives as low flows have reduced quality habitat during this critical life cycle. Additionally, well-oxygenated riffles (at appropriate depths and flow velocities) and glides were all included to provide the range of habitat typical of a healthy ecosystem. A meandering low-flow channel was constructed within the larger existing channel. During lower flows, all the water is contained within this area, which greatly increases the water depths and trout habitat. The design will increase the overall holding capacity of the stream and create a diverse fishing experience. Additionally, the final design will provide the fisherman with a wide variety of fishing opportunities from deep pools, rock features, riffles and glides/runs (see Photos 1 and 2).

The river restoration followed a naturalistic approach with the goal of establishing natural stream function and appearance. None of the typical, structural habitat features often used in river restoration designs, such as jetties, vortex structures or weirs was incorporated in the design. The goal of the design was to create a restored river that does not have the appearance of having been tampered with by man, but functions as and has the appearance of a natural stream (see Photos 1 and 2).

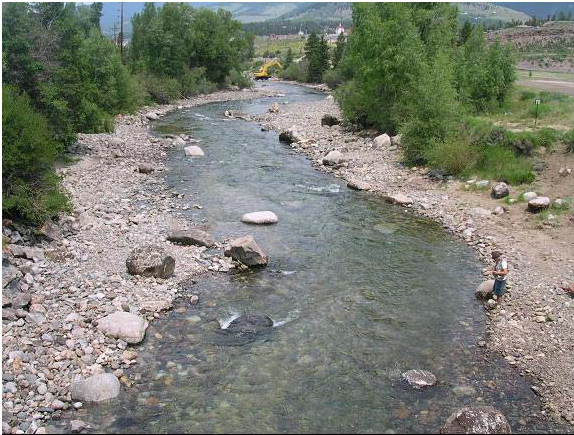
Photo 2. Post-construction, taken from bridge below dam.

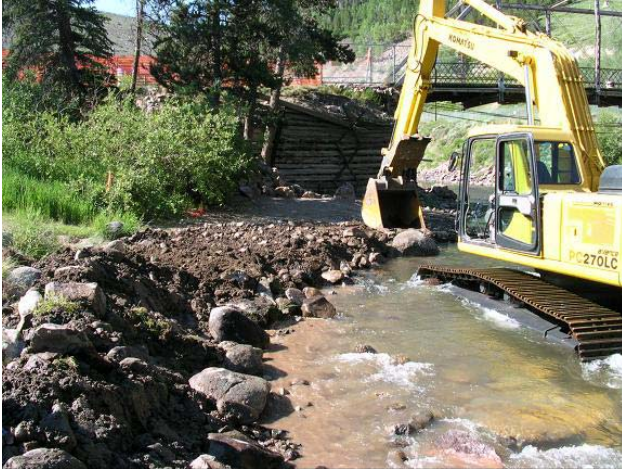
Photo 3. During construction, placement of large boulders to stabilize banks (d_{50} calculated by hydraulic engineer)

A fluvial hydraulic analysis was then conducted to assess stream bed and bank stability, determine the rock size required for a stable channel and estimate the natural variations in the stream's cross section through the different riffle, pool and glide sections. All of the calculations cannot be covered in this document, therefore a list of appropriate references are shown in Table 1. The information was used to design bank protection as shown in Photo 3.
